### 3809 REPORT OF INSPECTION

Date: Aug. 16, 2006 Time: about 11:30 am Location: T.5S. R.24E. Sec 6 Lots 6 and 13 and W2SENW

Serial no. of notice: UTU 66354 (Haslem project area) Is the operation active? No (expired)

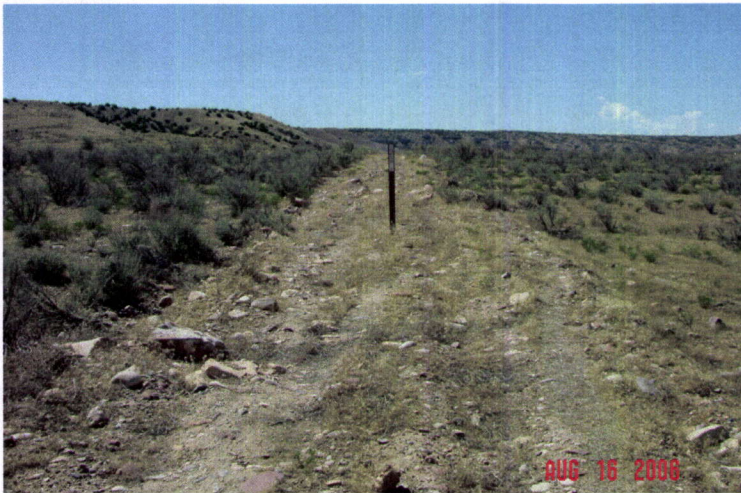
< image 1 view to south of former 6654 access that is signed as "closed" (on post in middle image). An recent track was seen in the path of this old two-track (that was ripped in August 2004). Compared with image 1 from the 2005 inspection, there is more vegetation emerging along this access and the amount of OHV travel has been less than observed during the prior inspection.

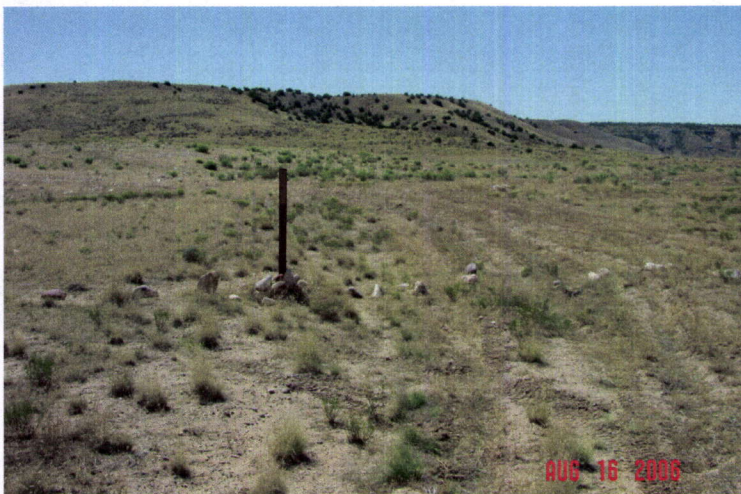
Description of operations (including access, reclamation, etc.): The subject area, which underwent reshaping and seeding in June 2001 has adequate desirable vegetative cover (denser than the surrounding undisturbed ground) and is stable (e.g., has not shown signs of erosion or mass wasting). There was only one set of ATV tracks that crossed into the reclaimed area (the off-road tracking by a truck sized vehicle observed during the last inspection was not apparent). The signage along the ripped access road from the north (image 1 attached) and a supplemental sign about the area having undergone reclamation (image 2 attached) are still in place.

< image 2, view to southeast of the former vehicular entrance into the northwestern part of the reshaped and seeded project area where a "reclaimed area" sign has been posted (along with a rim of oversized rock placed in an attempt to preclude vehicular traffic). The southern part of the reshaped area is beyond the sign and is showing desirable vegetative cover (in a density greater than the adjacent undisturbed ground [as shown in image 6 below]. ATV had tracked into the area (see tracking from lower-right to left-center). Compare with image 7 of the prior inspection.

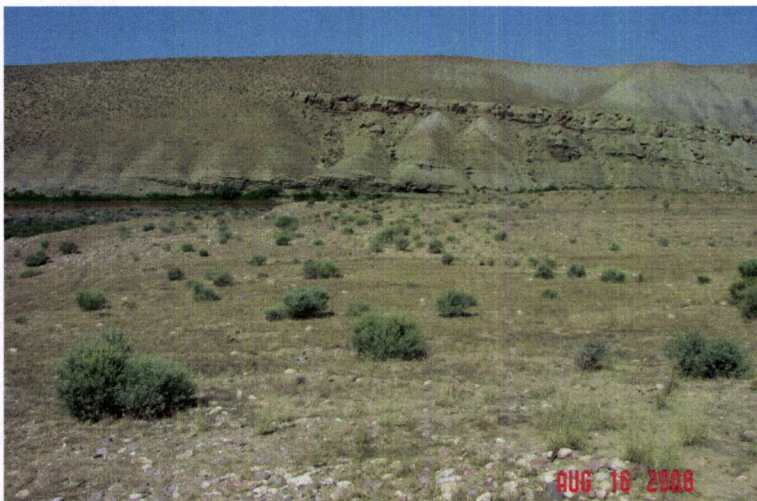
< image 3 view to west (from near SE corner of old project area). Compared with image 2 of the 2005 inspection, the desirable vegetative cover is now greater in density than the adjacent undisturbed ground, the off-road rutting by a larger vehicle is hardly noticeable, and the area is stable and I did not notice any noxious plant species.

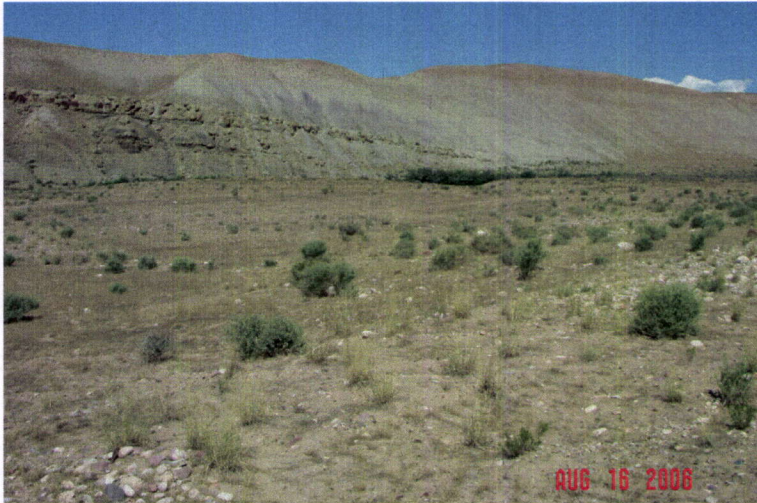
< image 4 view to west-northwest (pan to the right of image 3). Compared with image 3 of the 2005 inspection, the desirable vegetative cover is now greater in density than the adjacent undisturbed ground and I did not notice any noxious plant species, the area is stable and the vegetation is masking the areas that have a lot of cobble material exposed (in the north side of one of those areas is in the far-right of this image).

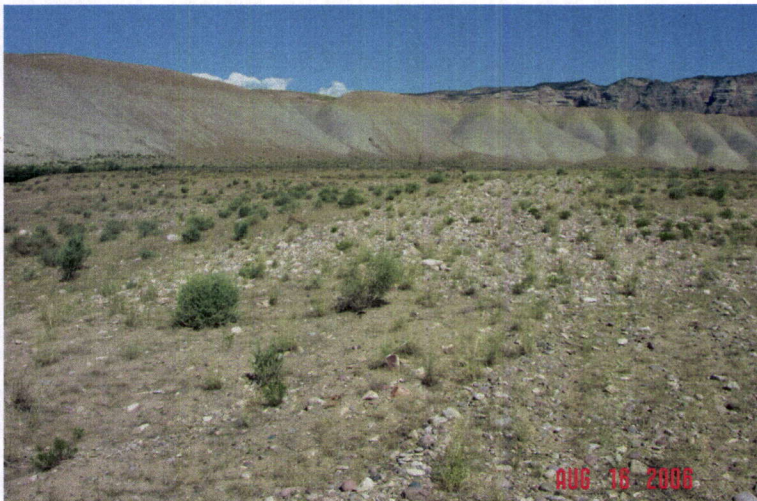
< image 5 view to north (pan to the right of image 4). Compared with image 4 of the 2005 inspection, the desirable vegetative cover is now greater in density than the adjacent undisturbed ground and I did not notice any noxious plant species, the area is stable and the vegetation is masking the areas that have a lot of cobble material exposed (center-right of this image; the shrubs seen to be doing particularly well within this area of exposed cobble).

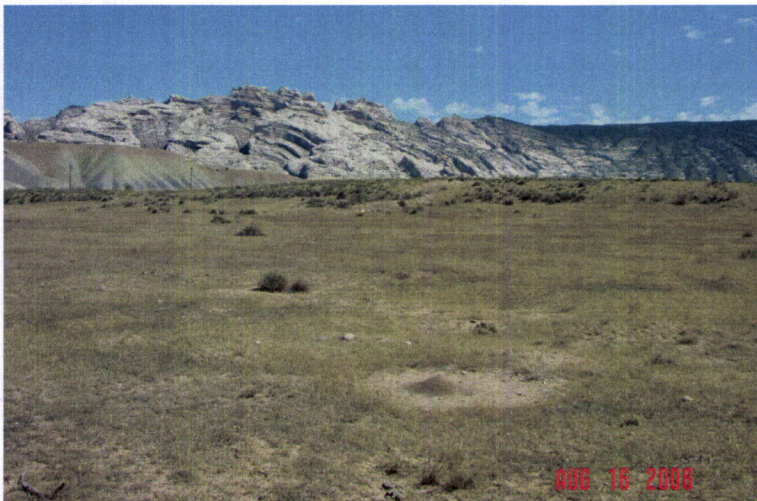
< image 6, view to north-northeast of undisturbed ground to the east of the reclaimed area in images 2-5. This ground is dominated by cheat grass with a scattering of shrubs. The reclaimed area has a higher density of desirable grasses (needle and thread, and rice grass) and shrubs (sage and saltbush).
